## **Decontamination of Hot Cells and Hot Pipe Tunnel at NASA's Plum Brook Reactor Facility - 8191**

Michael G. Anderson, William F. Haliashak  
MOTA Corporation  
3410 Sunset Boulevard, West Columbia, SC 29169  
United States of America

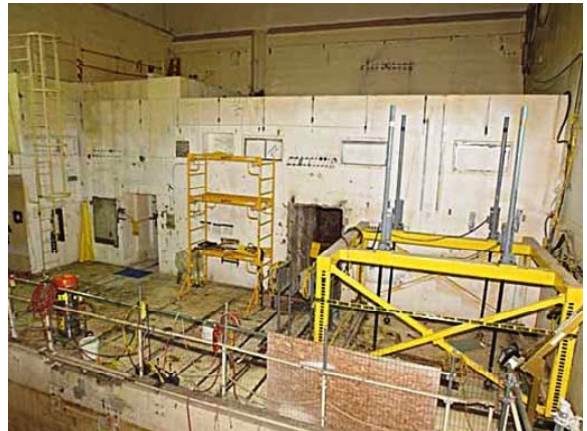
**Fig. 2. Hot Cell 1 and 2 prior to Remediation Efforts.**

There was a significant amount of fixed and loose equipment situated in HC 1. This was not the case regarding the physical status of HC 2 through 7 prior to remediation efforts. No loose equipment was located in any of these HC. A minimal amount of fixed equipment remained. The observation windows had previously been removed along with the stainless steel liner plates. The existing physical condition of HC 2 through 7 resembled the condition of HC 1 at the point in time that work activities recommenced after the first suspension.

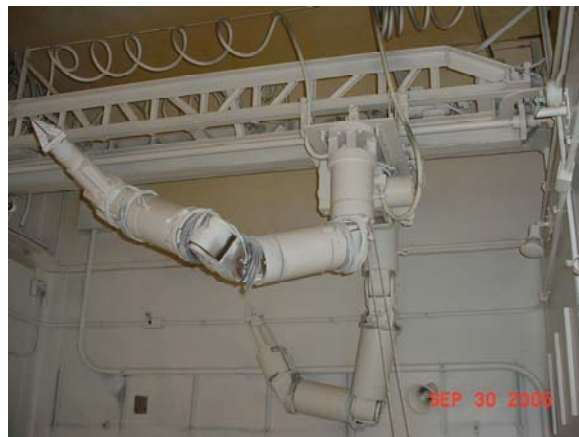
**Fig. 3. Fixed equipment such as these manipulator arms.**

HC 1 contained a significant amount of loose and fixed equipment. Examples of these items are shown in Figures 3 and 4. Some of the major loose equipment inventory included a hydraulically manipulated table, a shielded cask, a transfer tray, lead shielding bricks, and large piles of loose lead shot. Fixed equipment was defined as items extending beyond the surface of the cell, including overhead cranes, manipulator arms, stainless steel liner plates and, lead glass observation windows.

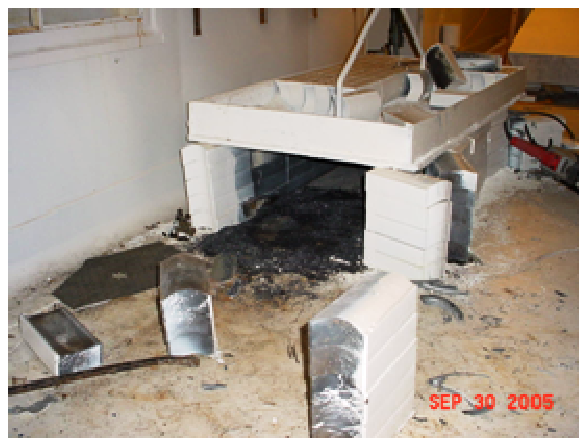
**Fig. 4. Loose equipment included items like this work table.**

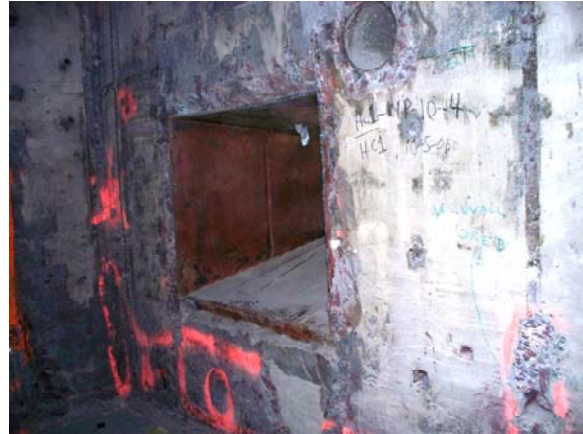
The removal of the embedded components left the surfaces of the HC in a “lunar landscape” like condition (Fig. 6). Simply put, the surfaces were so pockmarked that a conventional scabblers head would have been ineffective in removing all of the contamination located in the crevices and depressions on the HC surfaces. Hence, it was determined that the only effective means of decontaminating the HC surfaces would be to utilize remotely operated equipment to chip away at the contaminated concrete surfaces. An electrically powered demolition device was utilized as the tool carrier of choice.

**Fig. 6. Example of “Lunar Landscape” like surface resulting from initial remediation approach.**

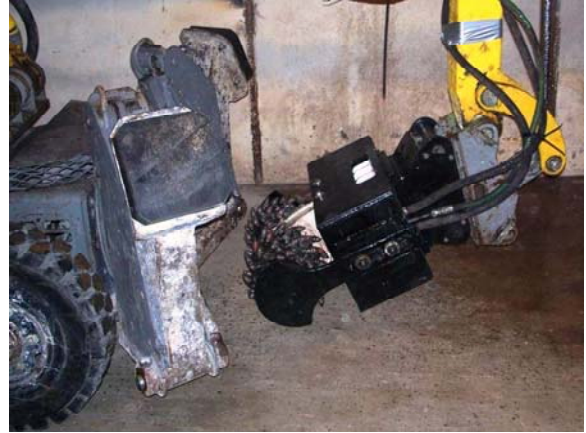
**Fig. 8. Scaling drum used to remediate the floors of hot cells and the hot pipe tunnel.**

Hydraulic hoe-rams and rotary cutters as shown in Figure 8 were used to remove bulk material from floor surfaces. These hydraulically driven tools are powerful, reliable, and efficient. They have been used for many years in confined space demolition projects mounted on many different styles of excavators.

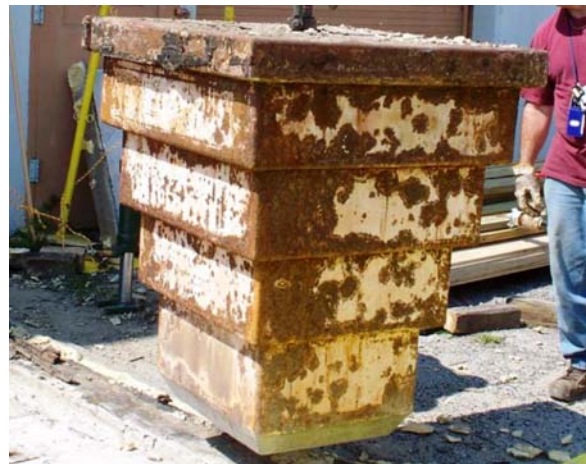
**Fig. 9. Steel jacketed concrete plug from the hot pipe tunnel prior to remediation efforts.**

free-release of 226,796 kg (500,000 lbs) of concrete and 45,359 kg (100,000 lbs) of steel. Current plans are to use the concrete material as backfill during site restoration (see Fig. 9 and Fig. 10).

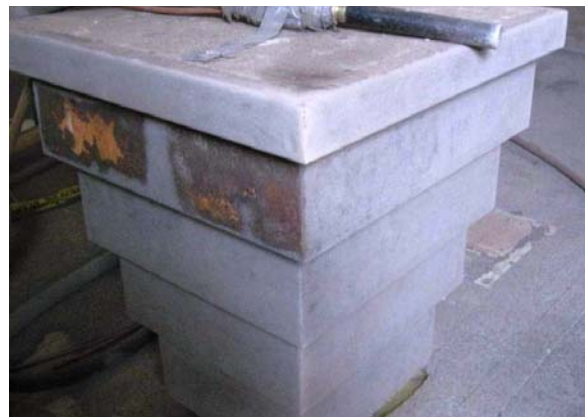
**Fig. 10. Remediated plug, free released and to be used as backfill.**

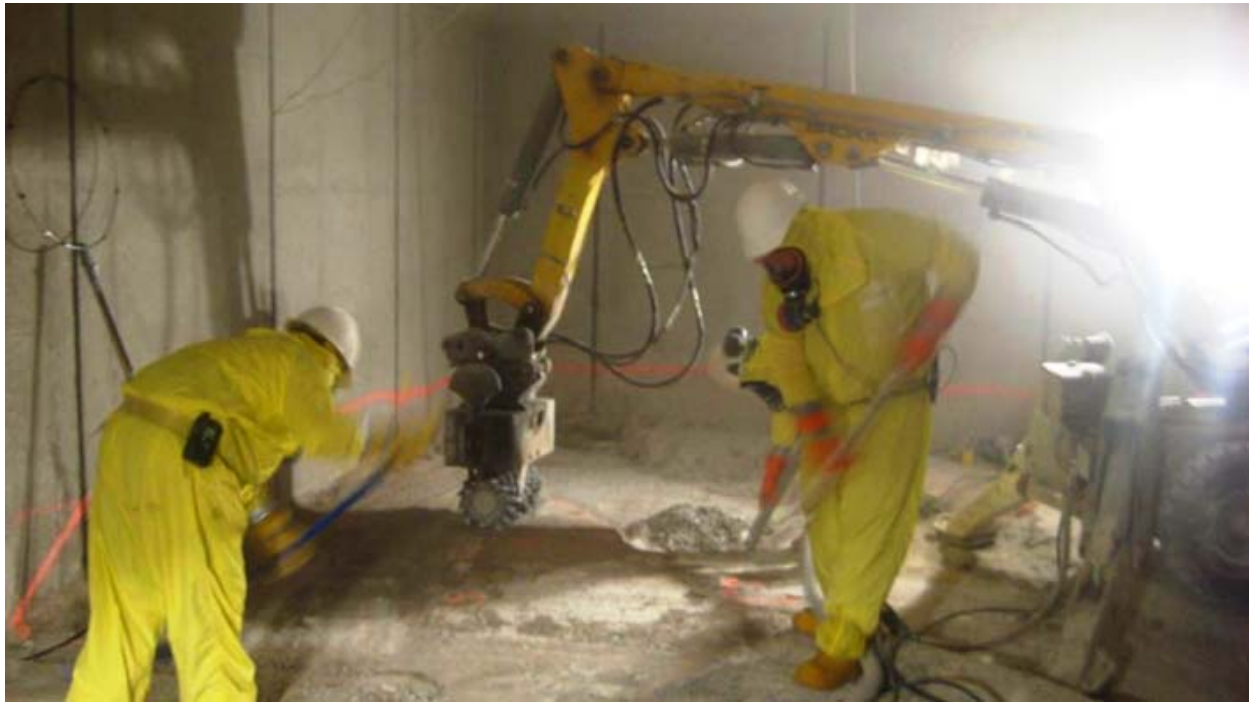
**Fig. 11. Actual spot remediation efforts within the hot pipe tunnel.**

The floor of the HPT was remediated by utilizing a scaling drum as shown above (Fig. 11). The scaling drum removed an average of 5 cm (2 in) of concrete from the floor slab. This reduced the residual contamination levels to 29,000 Bq/m<sup>2</sup> (17,500 dpm/100 cm<sup>2</sup>) over 95% of the tunnel floor area. By July 25, 2007, remediation efforts using the scaling drum were completed. Loose debris was removed and operational surveys conducted. These surveys revealed some areas requiring further spot remediation. All structural decontamination and radiological survey efforts were completed on September 20, 2007.
